# Your Inspection Report

123 Main Street  
Harrisburg, PA 17102

INSPECTION DATE:  
Friday, September 19, 2008

RE: Report No. 1483, v.11  
123 Main Street  
Harrisburg, PA  
17102

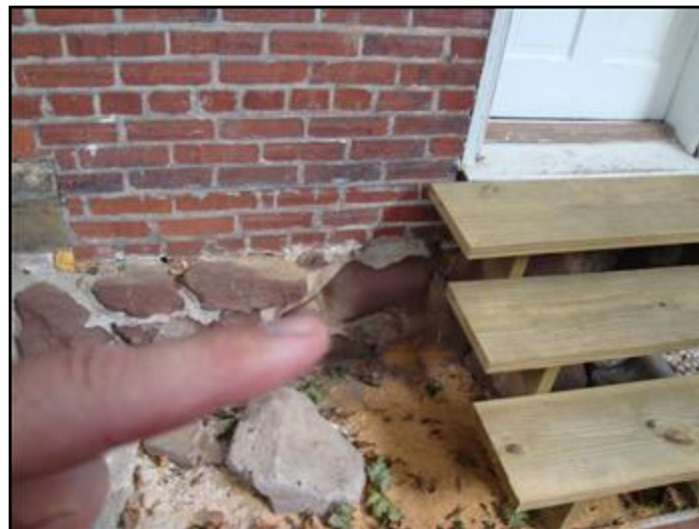
**Condition:** • [Missing](#)

2 steps or more should have a hand rail.

**Implication(s):** Fall hazard

1. rail needed

**Task:** Provide

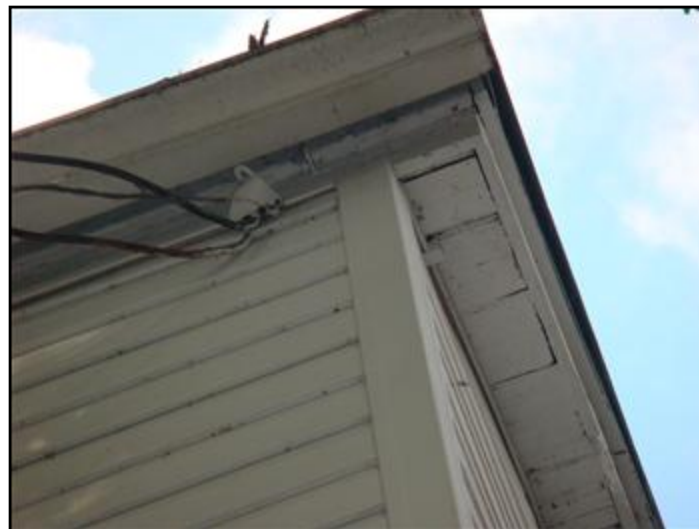
**Condition:** • [Conduit or cable covered by siding](#)

**Implication(s):** Electric shock

2. cable covered with siding

**Task:** Repair

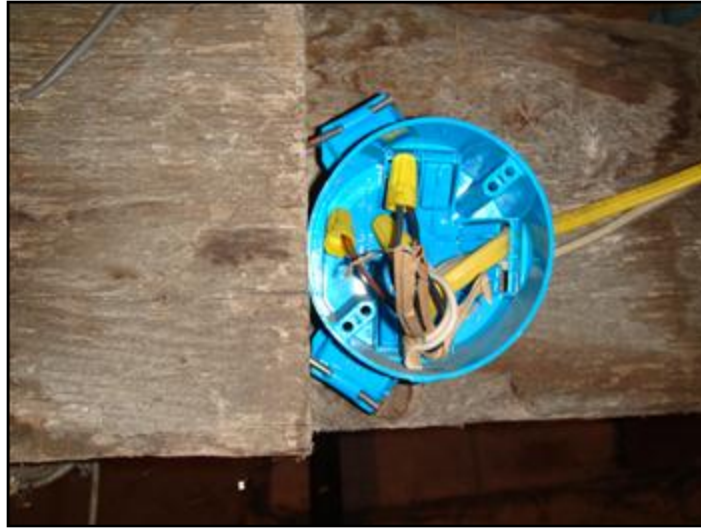
**Condition:** • [Cover loose or missing](#)

**Implication(s):** Electric shock | Fire hazard

3. cover j box

**Task:** Repair

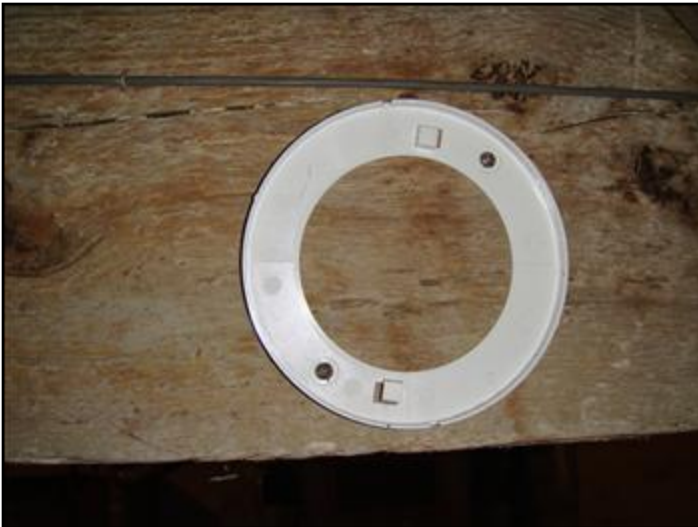
Condition: • [Inoperative](#)

Implication(s): Fire hazard

4. missing in basement

Task: Correct

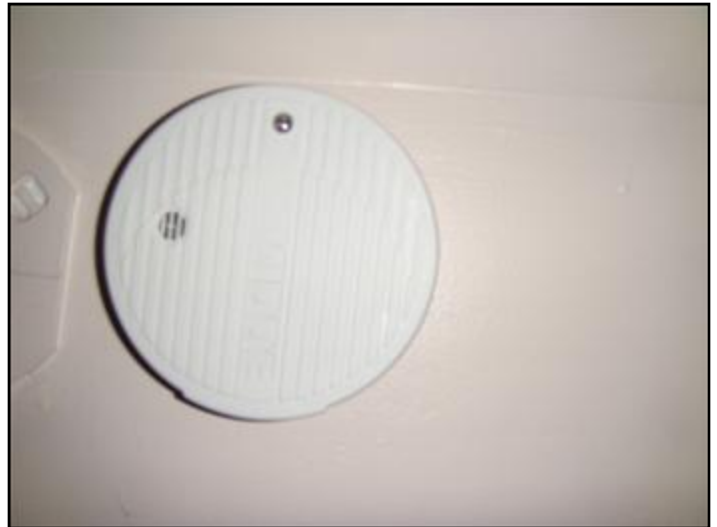
5. not working 2nd floor

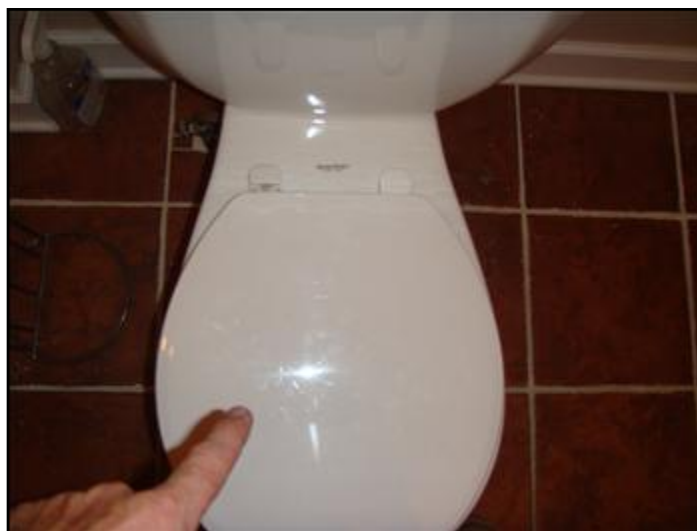
Condition: • [Loose](#)

Implication(s): Chance of water damage to contents, finishes and/or structure | Sewage entering the house

6. loose toilet

Re install toilet.

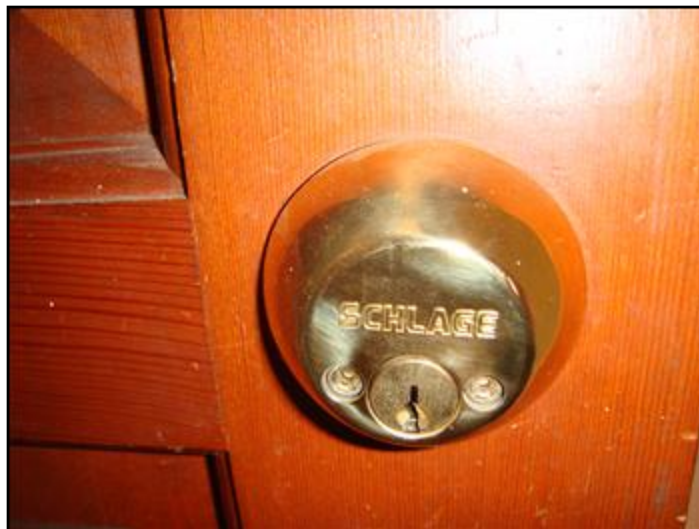
**Condition:** • Lock on the front door; this is dangerous in case emergency exit is needed. Change to a hand turn dead bolt.

7. keyed deadbolt

**Task:** Replace

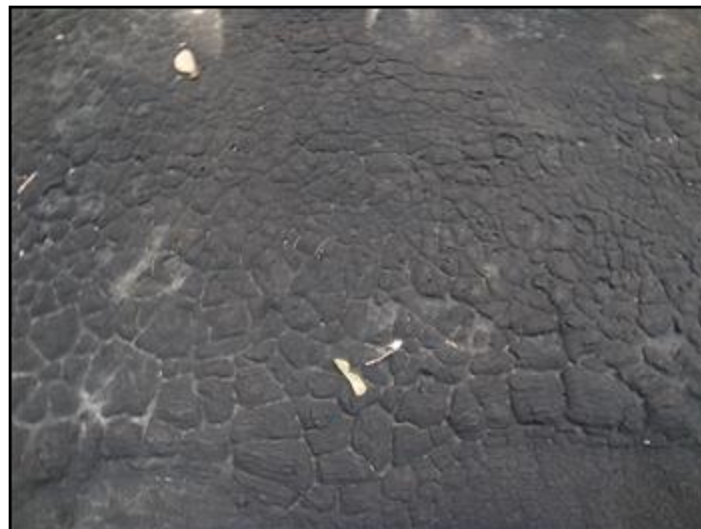
8.

**1. Condition:** • [Alligatoring](#)

No evidence of current leakage; monitor, keep roof coated (suggest elastometric coating) or replace as necessary.

**Implication(s):** Chance of water damage to contents, finishes and/or structure | Material deterioration

**Task:** Repair or replace

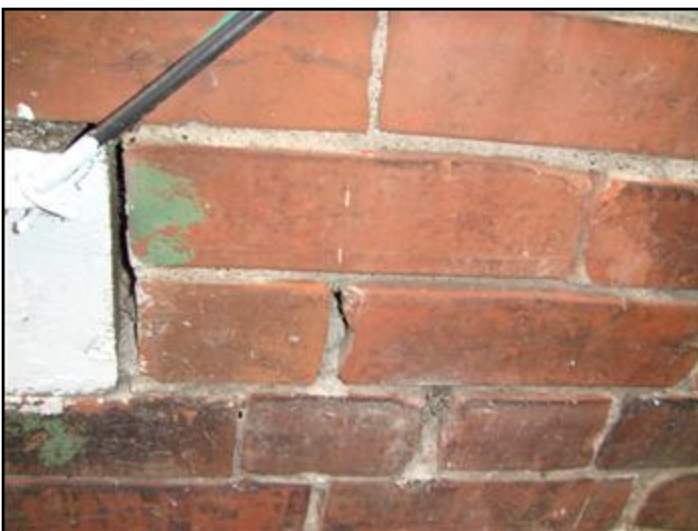
#### 2. Condition: • [Mortar deterioration](#)

Some minor brick repairs are needed at the rear of the property.

9. repoint

**Task:** Repair

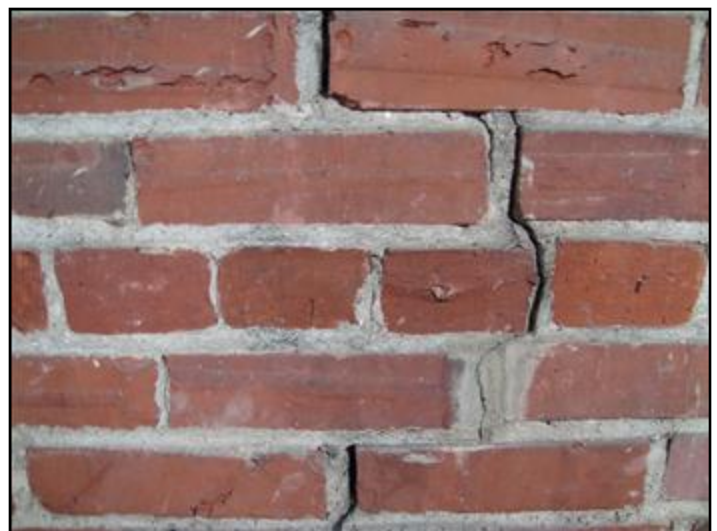
10. repoint

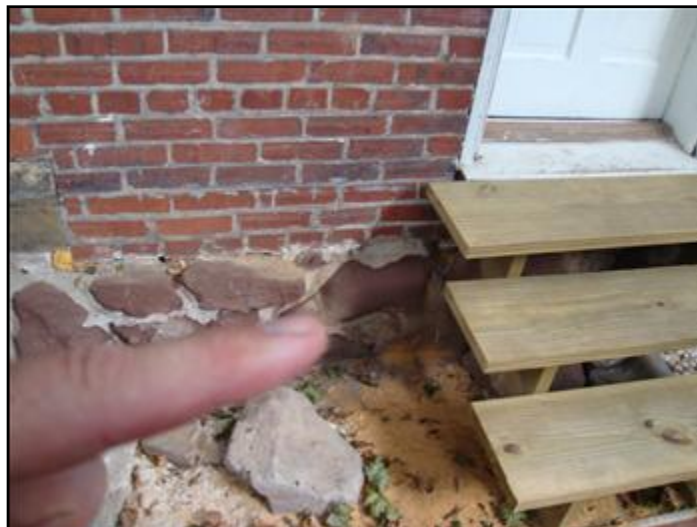
**3. Condition:** • [Missing](#)

**Implication(s):** Fall hazard

11. rail needed

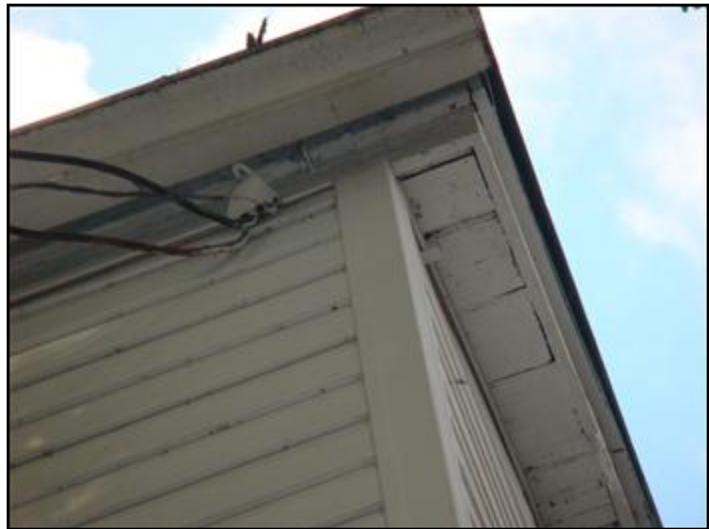
**4. Condition:** • [Conduit or cable covered by siding](#)

12. cable covered with siding

**Task:** Repair

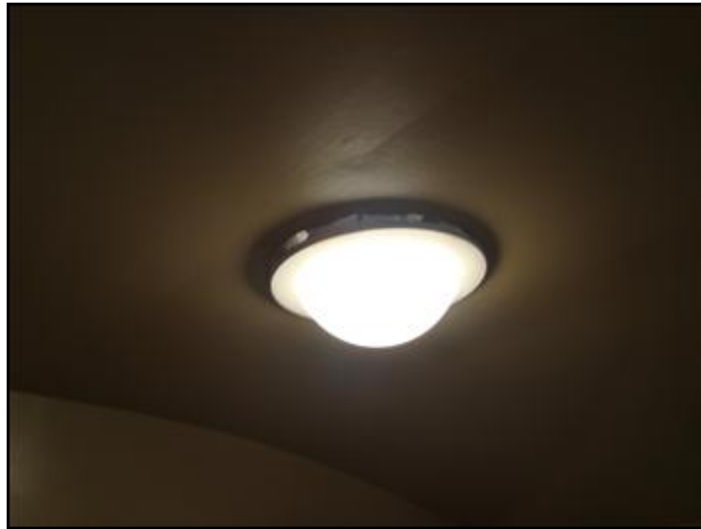
5. Condition: • [Loose](#)

Implication(s): Electric shock | Fire hazard

13. loose light

Task: Repair

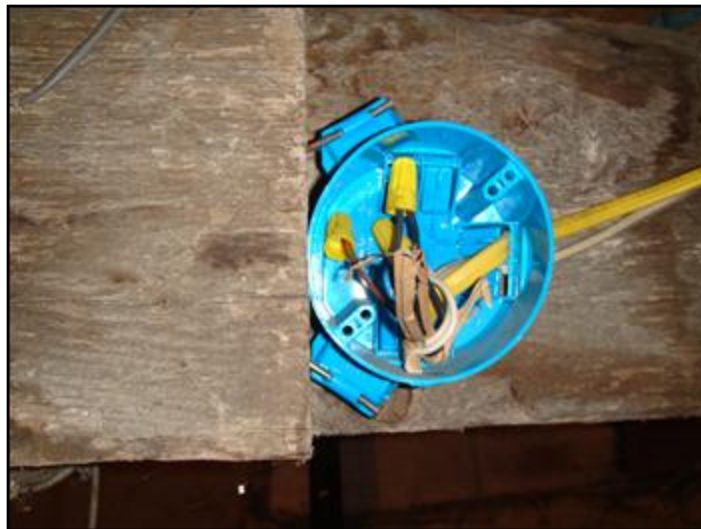
6. Condition: • [Cover loose or missing](#)

Implication(s): Electric shock | Fire hazard

14. cover j box

Task: Repair

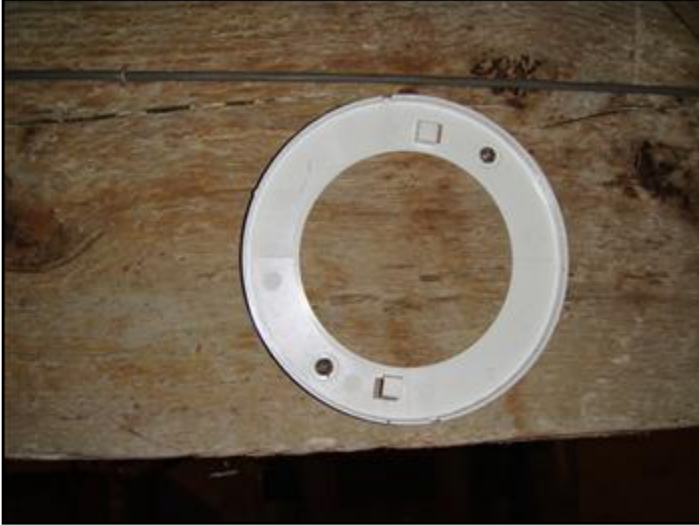
**7. Condition:** • [Inoperative](#)

**Implication(s):** Fire hazard

15. missing in basement

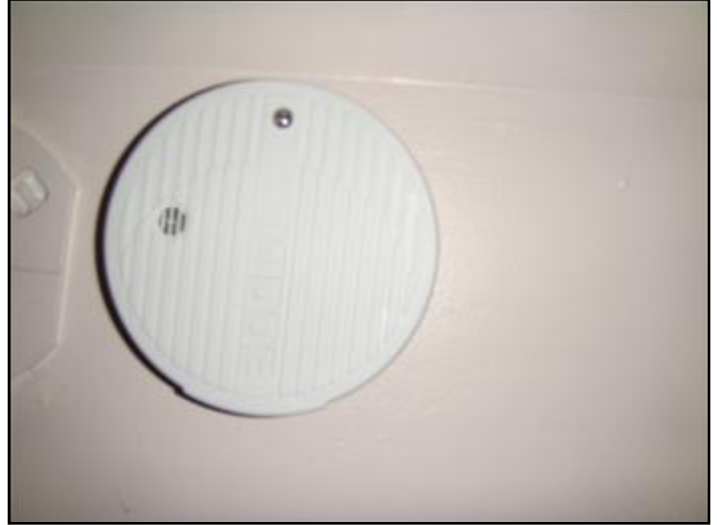
16. not working 2nd floor

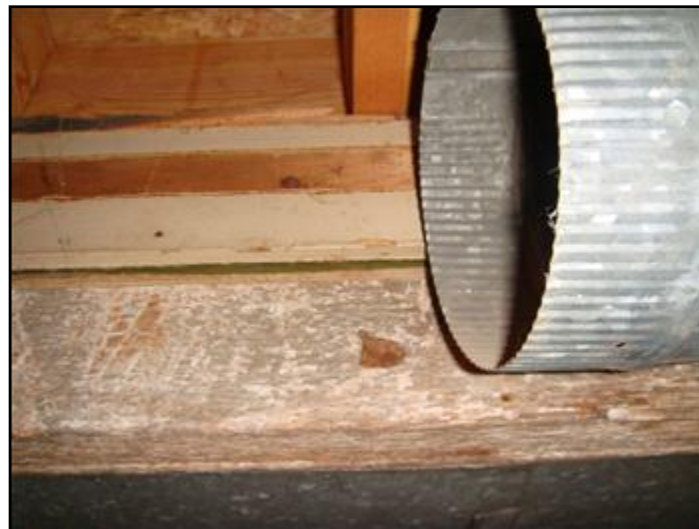
**8. Condition:** • [Disconnected ducts](#)

17. supply duct

**Task:** Repair

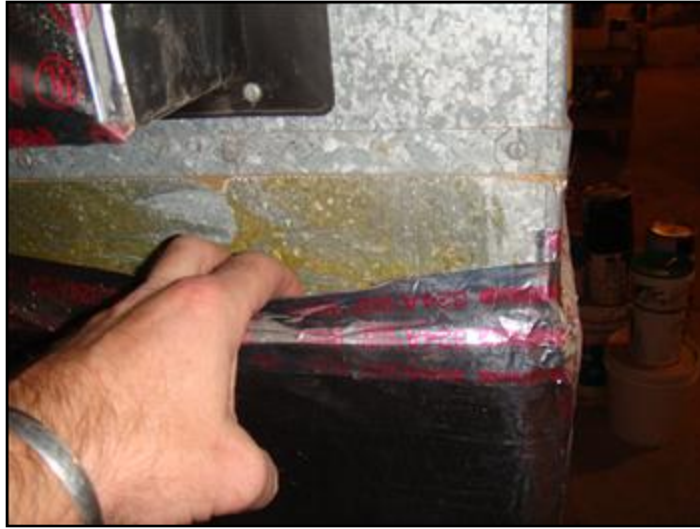
**9. Condition:** • [Leaky joints](#)

18. *leaky joints*

**Task:** Repair

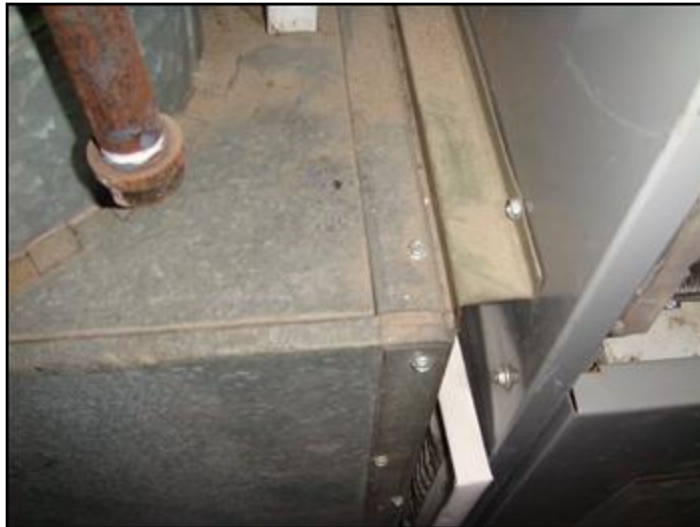
**10. Condition:** • Filter housing is open which will result in dirty air being sucked into system. Filter is the wrong size for the housing. Recommend repair by an HVAC contractor.

19. *open housing*

**Task:** Repair

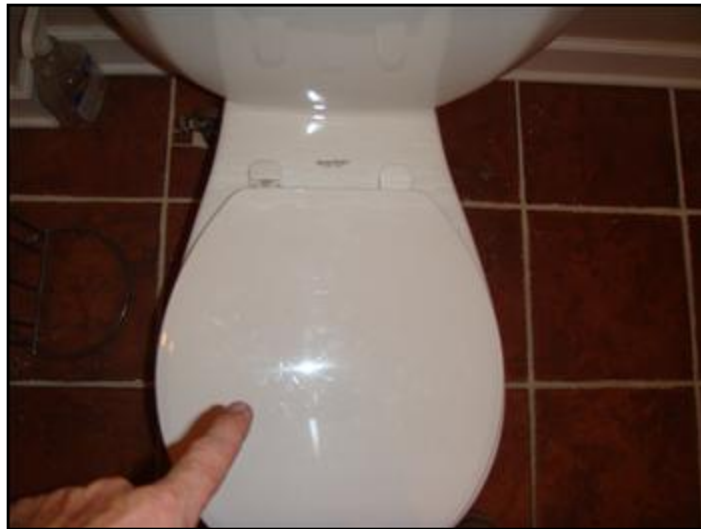
**13. Condition:** • [Loose](#)

**Implication(s):** Chance of water damage to contents, finishes and/or structure | Sewage entering the house

20. loose toilet

**Task:** Repair

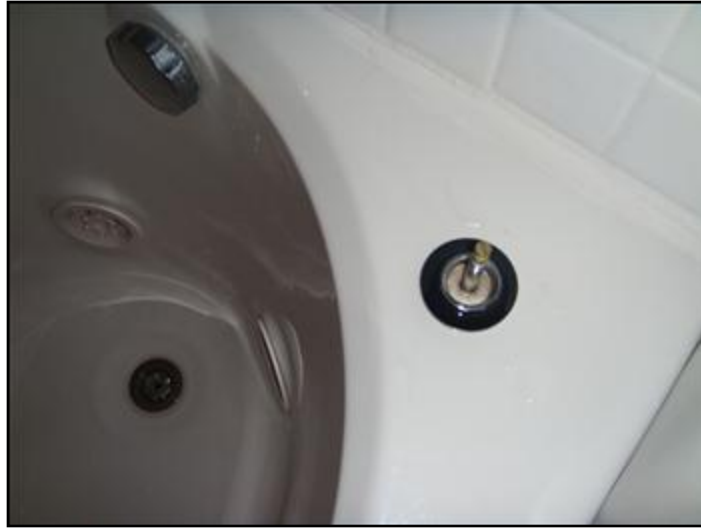
**14. Condition:** • Drain stop ineffective

21. stopper broken

**Task:** Repair

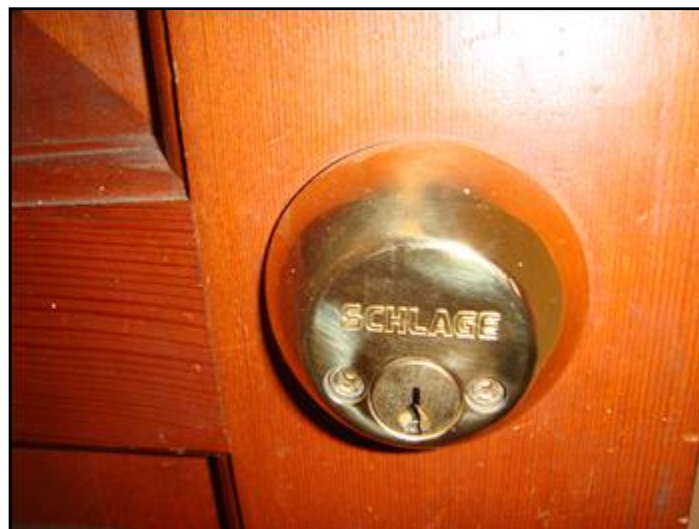
**15. Condition:** • Lock on the front door; this is dangerous in case emergency exit is needed. Change to a hand turn dead bolt.

22. keyed deadbolt

**Task:** Replace
